Appendix K—Streambank Stability

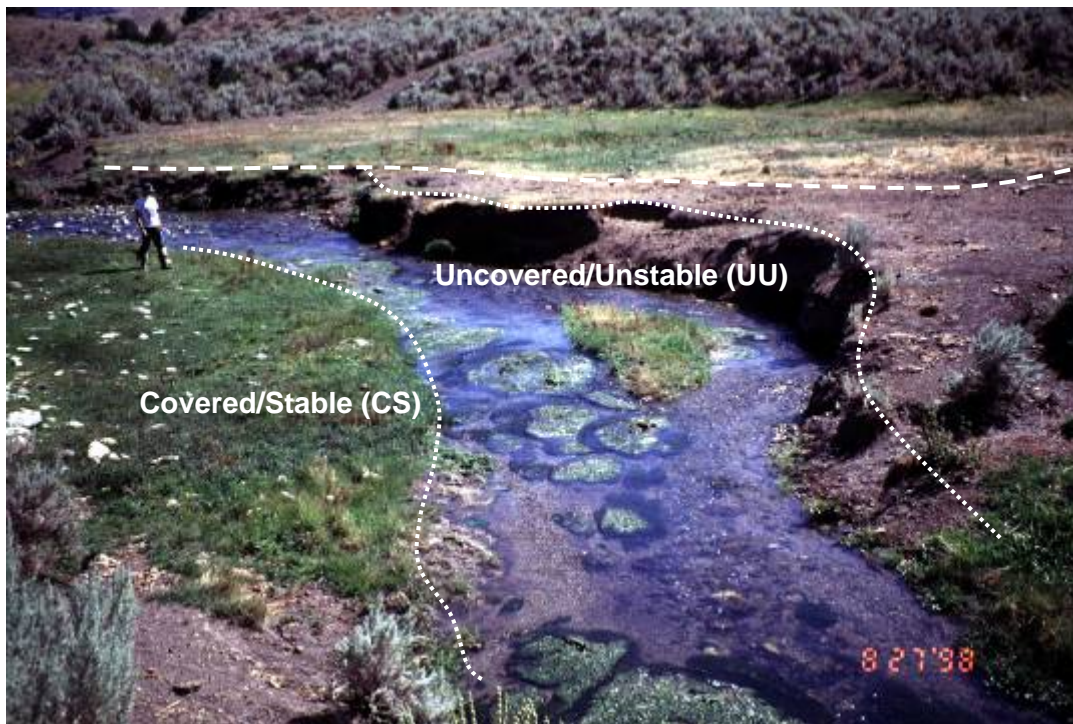
Figure 19—this is one of the few exceptions to following the greenline (dashed line). Because the greenline deviates from the stream, the monitoring line flows the stream until the greenline is closer to the streambank. The scour line (dotted line) is near the surface water level.

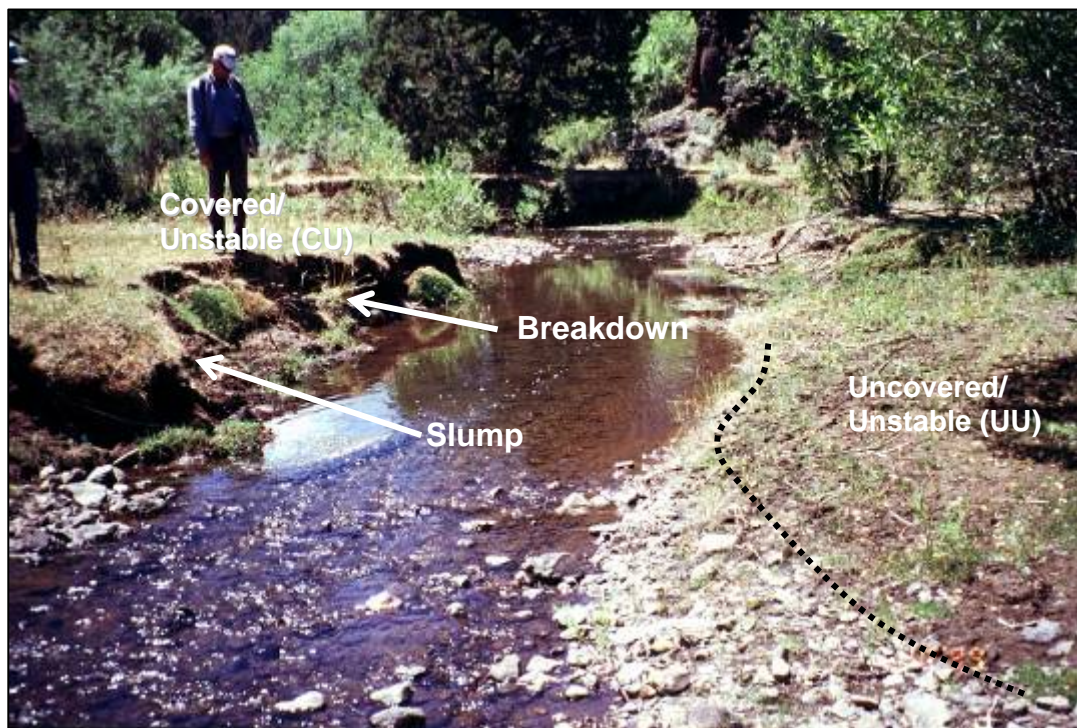
Figure 20—the left bank contains slumping banks and breakdown is covered/unstable (CU). The right hand bank is a point bar with less than 50 percent vegetative cover. The condition of the right bank is uncovered/unstable (UU).

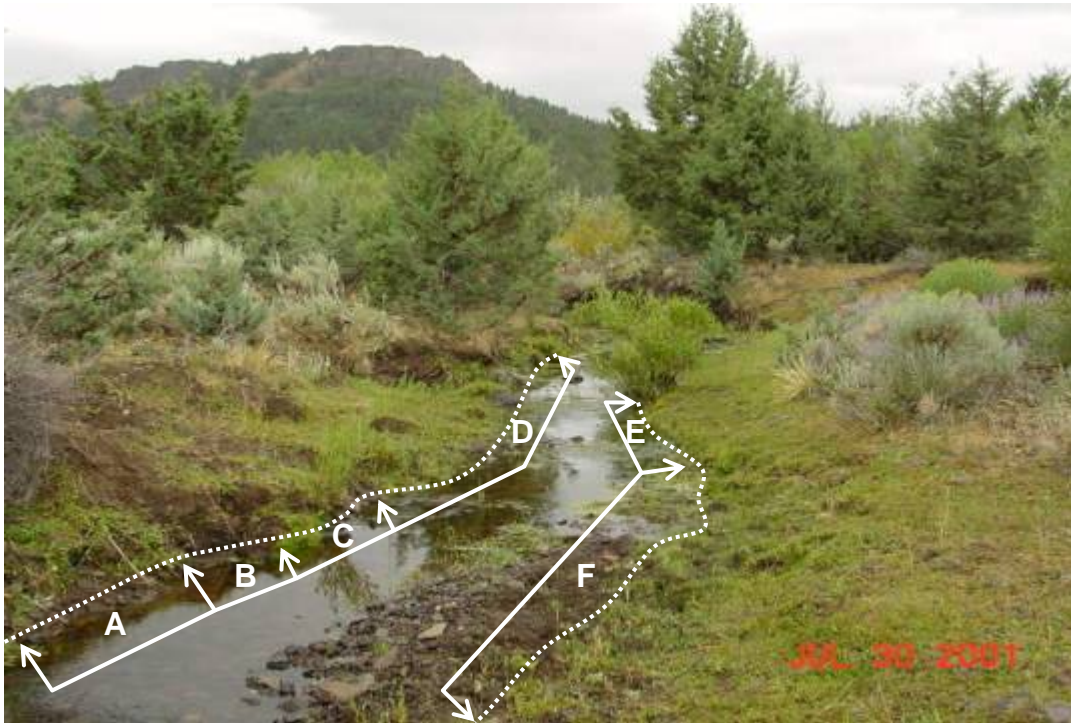
Figure 21—the dotted line in the scour line. “A” has bare bank above the scour line with vegetation on top (covered/unstable (CU). “B” is uncovered/unstable (UU). “C” is covered/unstable (CU). “D and E” has a vegetation cover with little erosion, covered/stable (CS). And, “F” is covered/unstable (CU) as a result of livestock trampling.

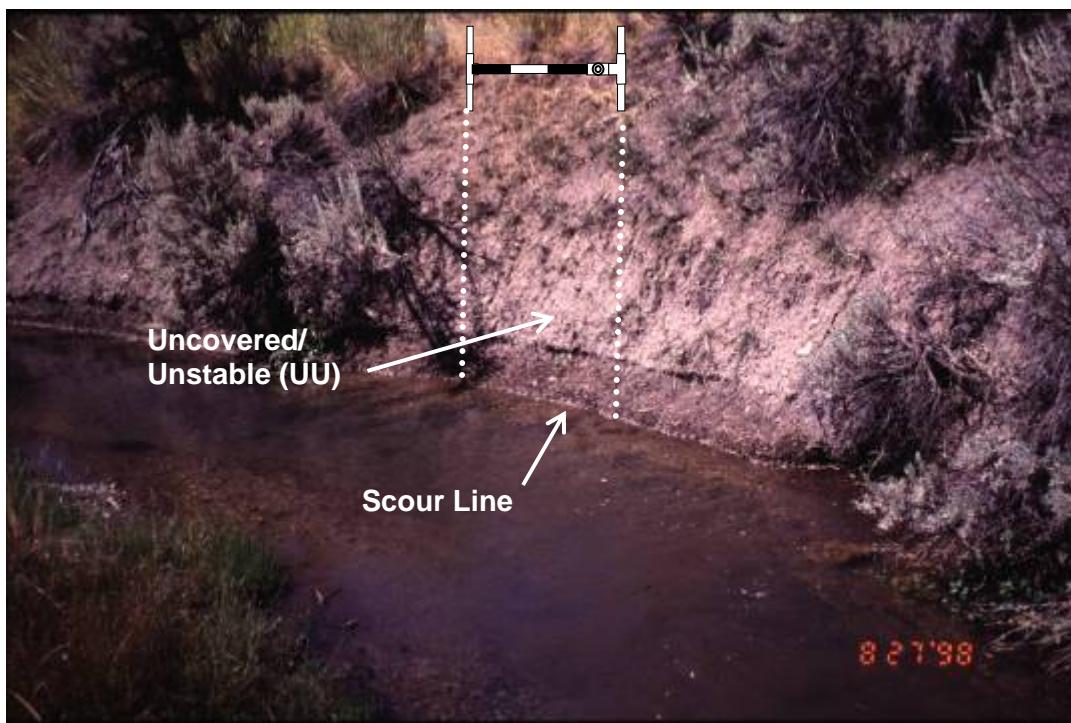
Figure 22—sour material is directly entering the stream. The streambank is above the scour line and is uncovered/unstable (UU).

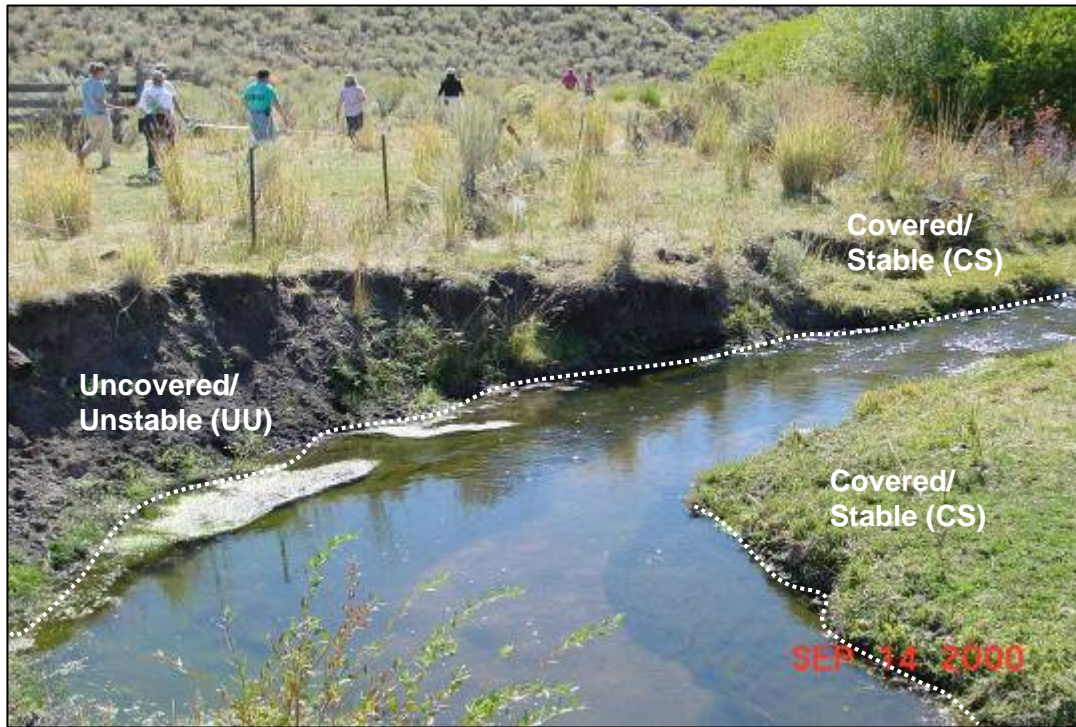
Figure 23—the scour line is near the current water level. The streambank classification reflects the scour line and the vegetation.

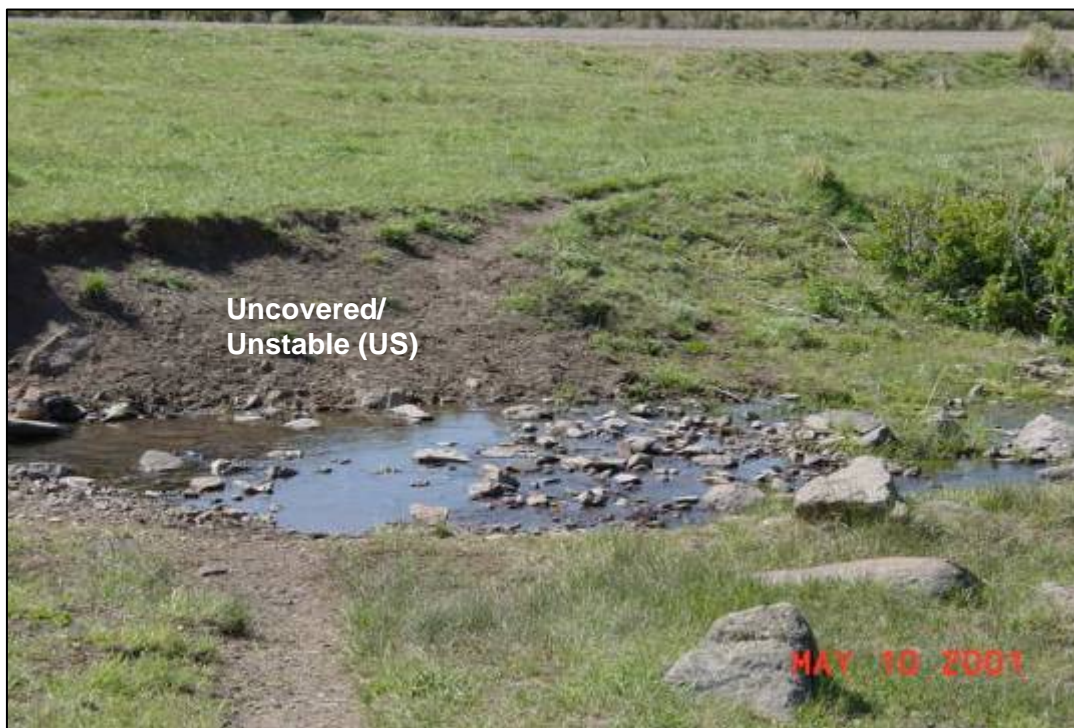
Figure 24—highly compacted areas such as this livestock trail and slough is directly entering the stream is classified as uncovered/unstable (UU).

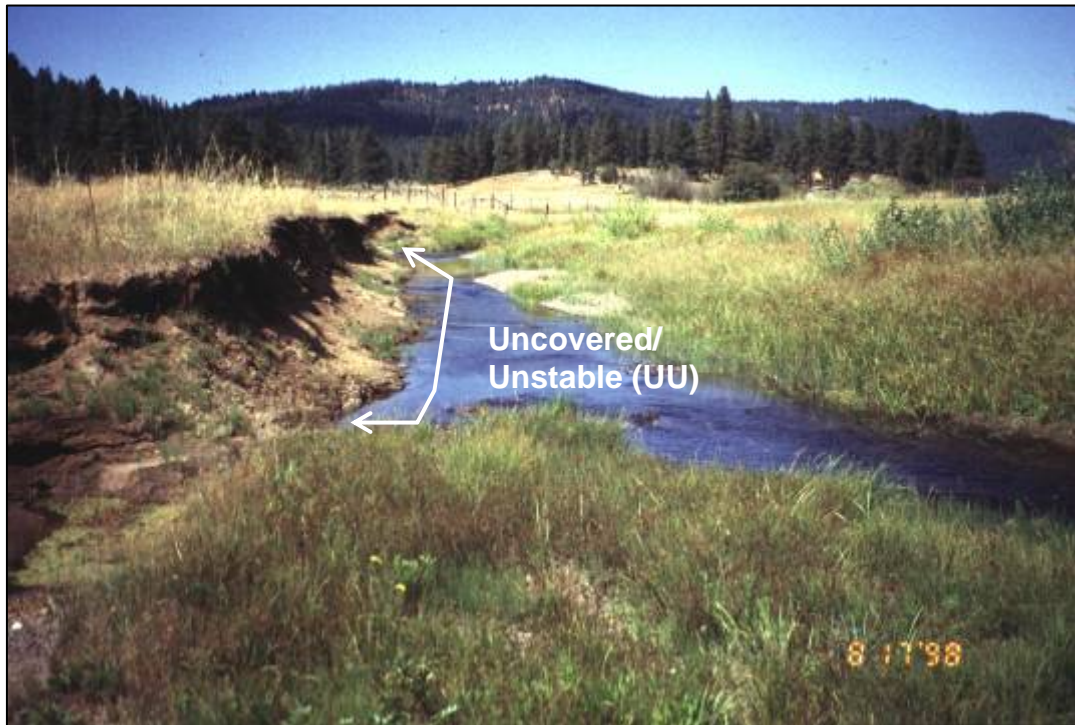
Figure 25—the streambank is not covered with vegetation, rock, or wood. It has a bank angle of more than 10 degrees from vertical with no terrace to capture the sediment and thus the sediment enters directly into the stream making it uncovered/unstable (UU).

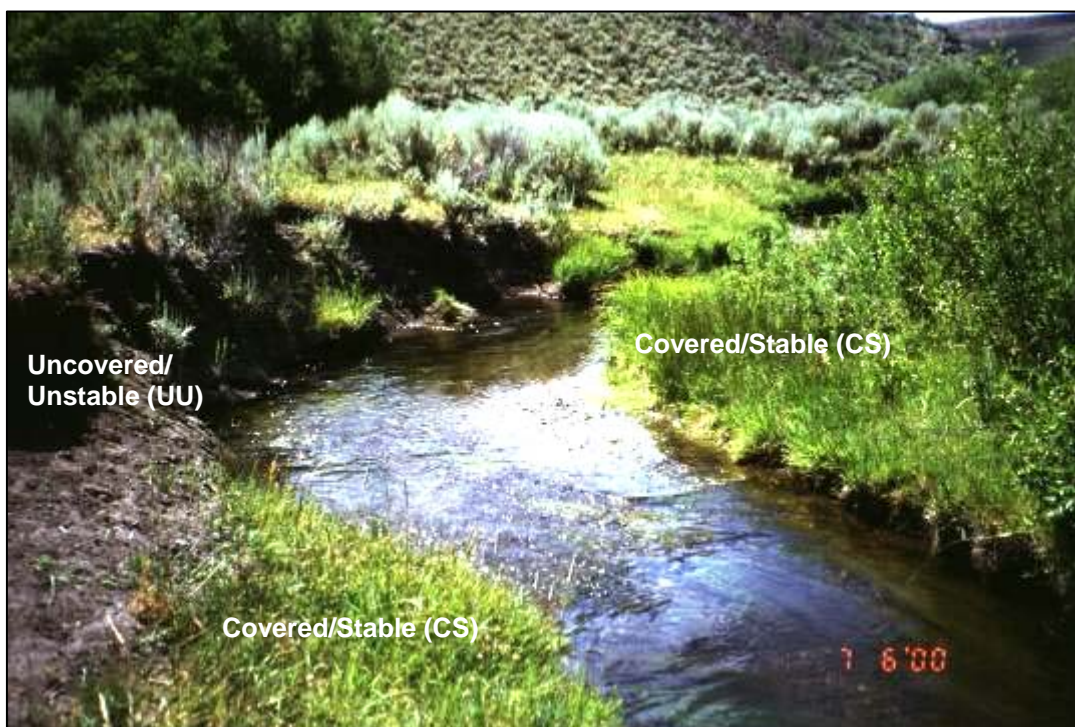
Figure 26—these streambanks include areas that are covered/stable (CS) on the inside bends and uncovered/unstable (UU) on the outside of the bends.
